**[Docket No. 2002-SW-55-AD; Amendment 39-13060; AD 2002-25-51]**

#### **Airworthiness Directives; Agusta S.p.A. Model A109E Helicopters**

**2002-25-51 Agusta S.p.A (Agusta):** Amendment 39-13060, Docket No. 2002-SW-55-AD.  
Supersedes AD 2002-17-51, Amendment 39-12936, Docket No. 2002-SW-42-AD.

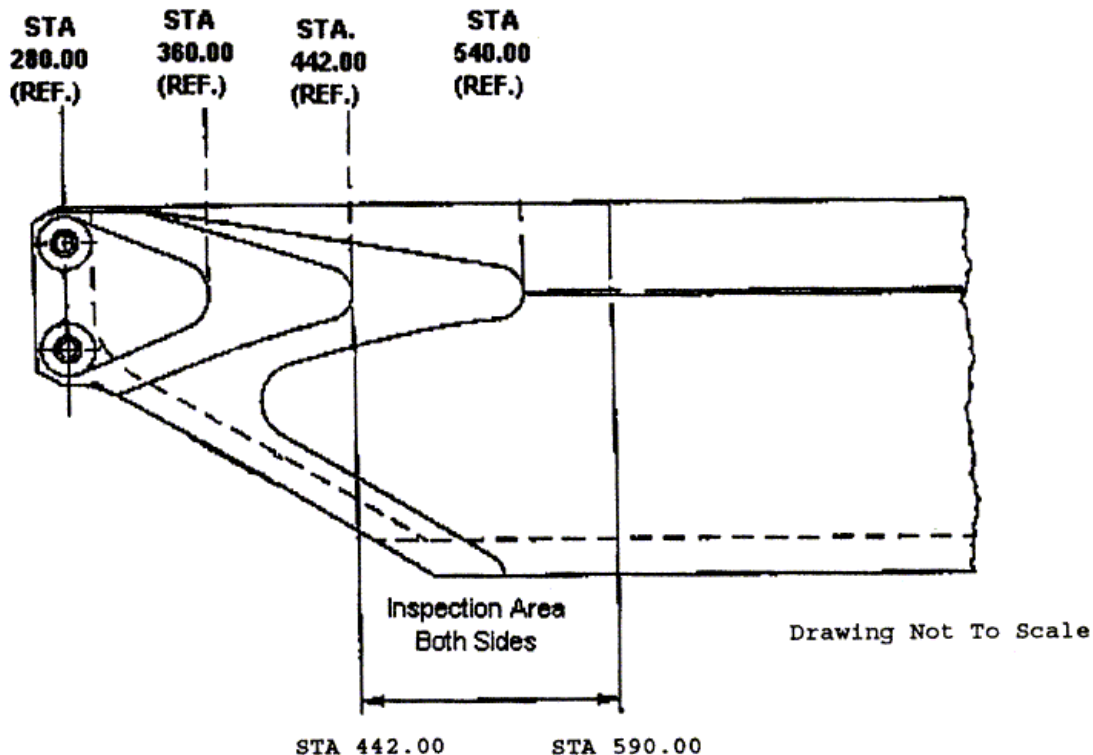
**FIGURE 1**

(b) Before each start of the helicopter engines, visually check both sides of each tail rotor blade for a crack in the area depicted in Figure 1 of this AD. An owner/operator (pilot) holding at least a private pilot certificate may perform this visual check and must enter compliance with this paragraph into the aircraft maintenance records in accordance with 14 CFR 43.11 and 91.417(a)(2)(v). See Figure 1:

**Part Number 109-8132-01-111 Tail Rotor Blade**

(h) Before each start of the helicopter engines, visually check both sides of each tail rotor blade for a crack in the area depicted in Figure 1 of this AD. An owner/operator (pilot) holding at least a private pilot certificate may perform this visual check and must enter compliance with this paragraph into the aircraft maintenance records in accordance with 14 CFR 43.11 and 91.417(a)(2)(v). See Figure 1.

(c) Within 5 hours time-in-service (TIS), and thereafter at intervals not to exceed 5 hours TIS, and before further flight any time there is an increase in vibration levels:

(1) Using a 5x or higher magnifying glass, visually inspect each T/R blade for a crack in accordance with the Compliance Instructions, Part III, paragraphs 1. through 5., of the ABT. Reporting to Agusta Service Engineering is not required.

(2) If you are unable to determine by the visual inspection whether there is a crack, dye-penetrant inspect the T/R blade for a crack in accordance with the Compliance Instructions, Part III, paragraph 6., of the ABT.

(d) Before further flight, replace any unairworthy T/R blade with an airworthy blade.
